LANDSLIDES AND RELATED FEATURES

OF THE GLADY, W.VA. QUADRANGLE

Roger E. Thomas and Robert J. Hackman 1980

> U.S. Geological Survey OPEN FILE MAP 80-194 (G-3)

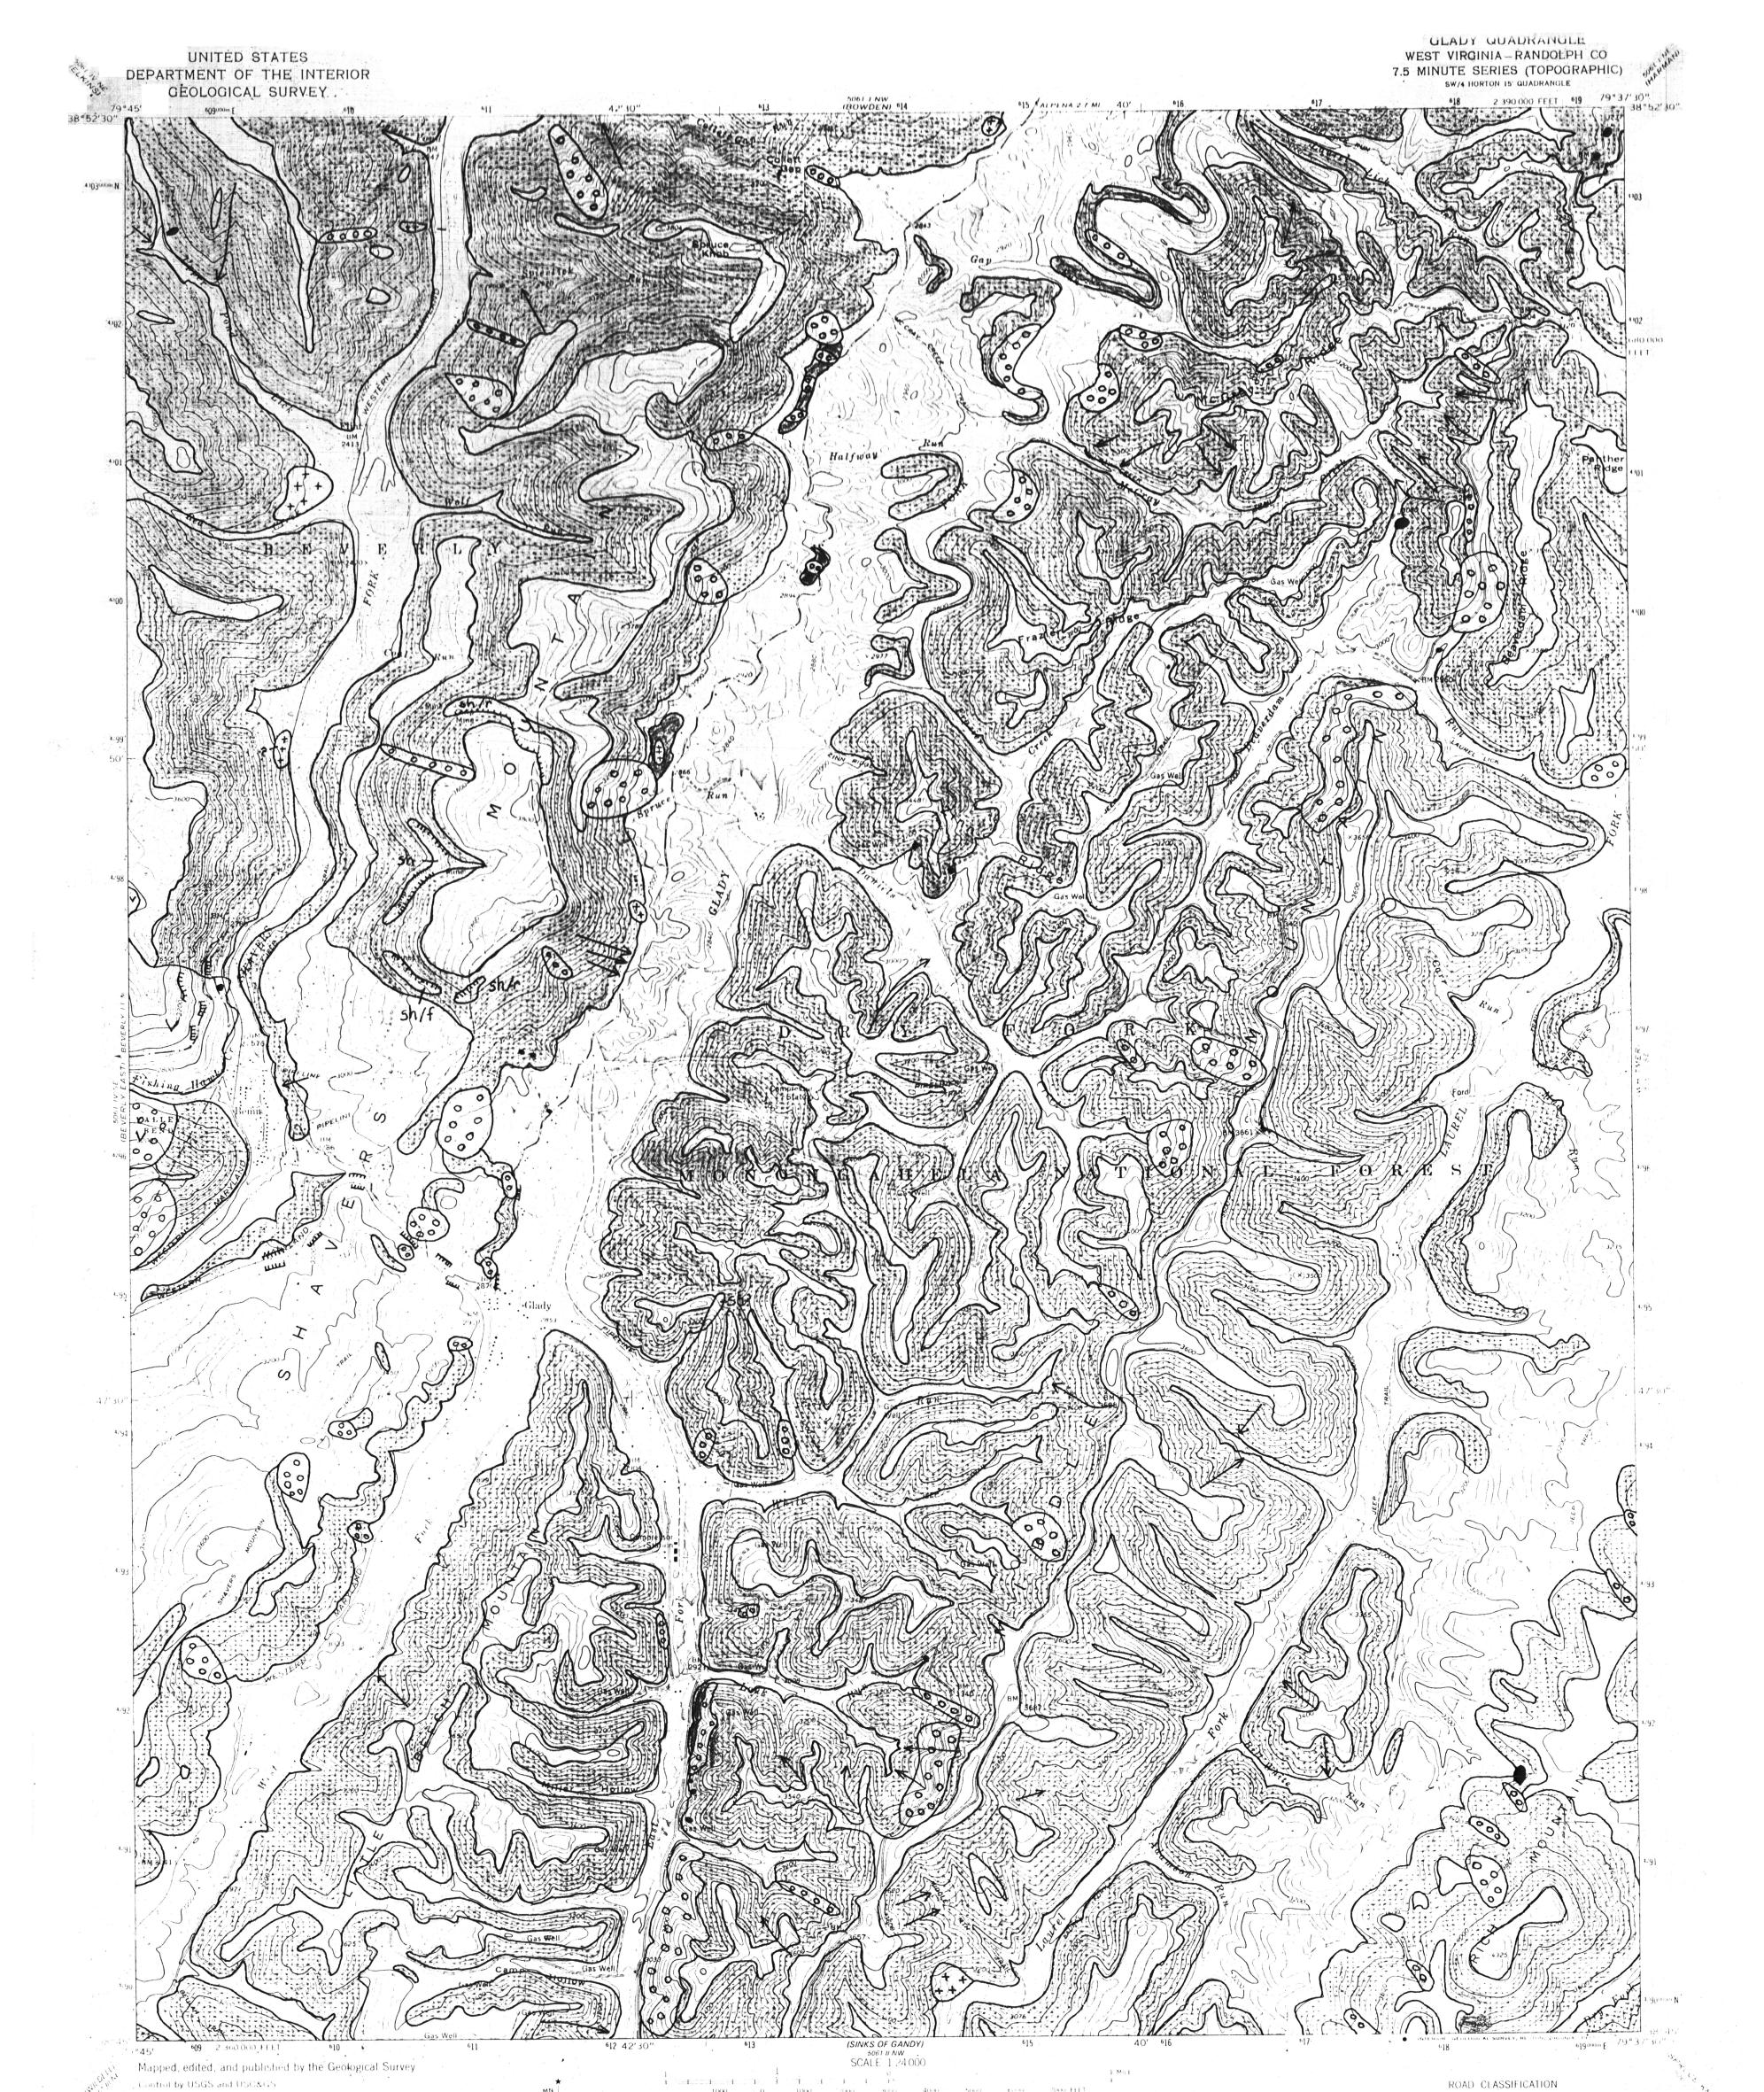
Landslides and related features interpreted from aerial photographs:

Topography by photogrammetric methods from aerial photographs taken 1964 and 1965. Field checked 1968

ACTIVE OR RECENTLY ACTIVE LANDSLIDE Complex landslide composed of earthflow, debris slide, earth and rock slump. Identified from historical records, and from scars, debris and other field evidence. Ground extremely unstable; sliding accelerated by excavation, loading and changes in drainage conditions. May include areas with several active slides too small to be shown separately. Questioned where doubtful.

OLD LANDSLIDE Area of extensive hummocky ground caused by earthflow and earth and rock slump. Lacks clear evidence of active sliding. Relatively stable in natural, undisturbed state, generally not affected by small structures properly sited in areas away from the edge of the toe; can be reactivated by extensive, rapid excavation, loading, and changes in ground water and surface water conditions. Area of old landslide probably includes recent ones not identified from field evidence or otherwise documented. Upslope boundary of landslide generally defined by modified scarp, but downslope (toe) may be gradational and not well defined. Questioned where doubtful.

COMBINATION LANDSLIDE Area of recent and old slides in which individual slides are not identified.

Valley wall along major streams with slope as steep as 40° (85%); stony, clayey silt soil up to 50 ft. (15 m) thick; commonly buttressed by a terrace or bench at the toe of the slope; very susceptible to silding by cutting of toe area, removal of terrace or bench, and overloading; slide commonly activated without apparent cause.

COLLUVIAL SLOPES WITH LANDSLIDES
Landslides too small or observe Landslides too small or obscure to map individually.

Primarily shallow, narrow ravines and chutes with accumulation of stony colluvium generally 10 ft. (3 m) or less in thickness; susceptible to rapid movement during intense rainfall. Most ravines and chutes designated show evidence of former debris flows and avalanches. Symbol & designates historical debris flow or debris avalanche.

AREAS SUSCEPTIBLE TO ROCKFALL m Steep, locally vertical, natural and man-made slopes and cliffs, 15 ft. (4.5 m) or more high; formed dominantly of sandstone, limestone, sandy shale, mudstone and claystone. Interbedded mudstone, claystone and shale weather rapidly leaving sandstone and limestone rock faces unsupported.

SOIL AND ROCK SUSCEPTIBLE TO LANDSLIDING Soil and rock similar to that involved in landslides elsewhere in map area; primarily areas underlain by claystone, mudstone and shale associated with other rock types. Rock weathers rapidly on exposure forming clayey soil highly susceptible to sliding. Includes coves (U-shaped, shallow valleys) containing thick layers of clayey soil that are very susceptible to sliding where excavation breaks continuity of slope and where

AREAS LEAST PRONE TO LANDSLIDES Map areas in which no patterns or symbols are shown; primarily valley floors, ridge tops and broad benches; modification by excavation and fill may lead to local landslides.
